# Home Inspection Report

## Jekel Inspections

**Pensacola, Florida 32514**

**Inspection Date** 12/13/2023

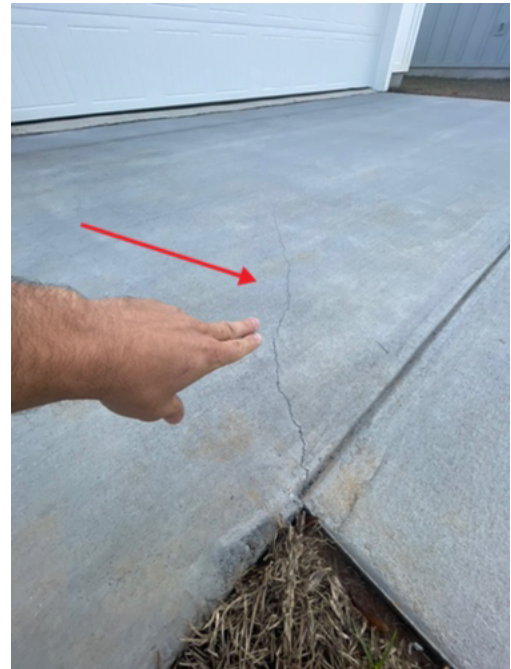
Exterior concrete driveway showed typical concrete crack near the garage area. Recommend monitoring as this can be typical of concrete.

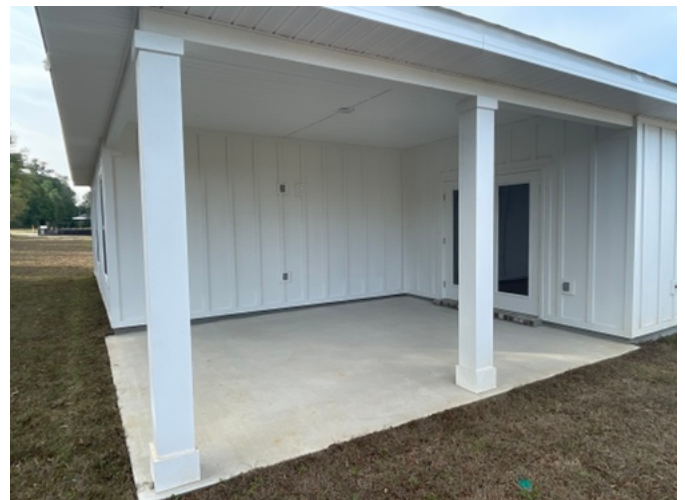
Exterior rear elevation porch had oversized cuts at trim around electrical outlet. Recommend improving finish.

Oversized trim cuts

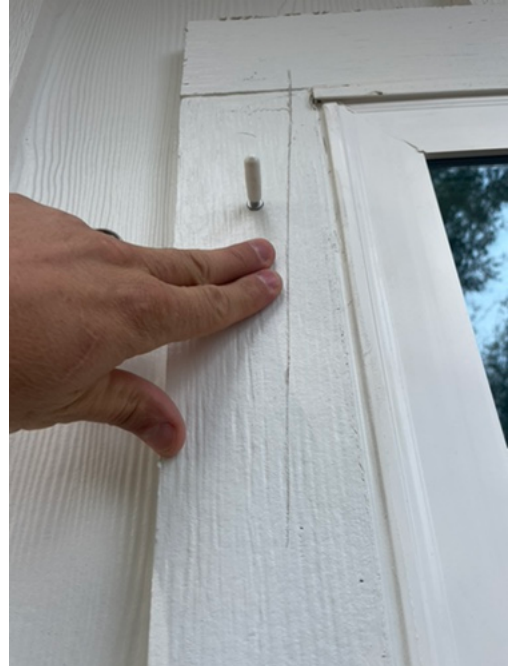
Rear elevation

Exterior rear elevation trim around left window had minor damage. Recommend improving finish.

Trim damage

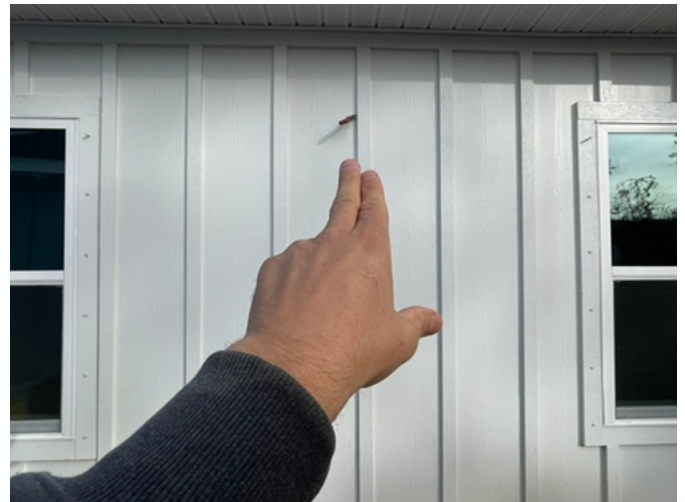
Right elevation

Exterior left elevation had cut damage to composite siding. Recommend repairing.

Siding damage location

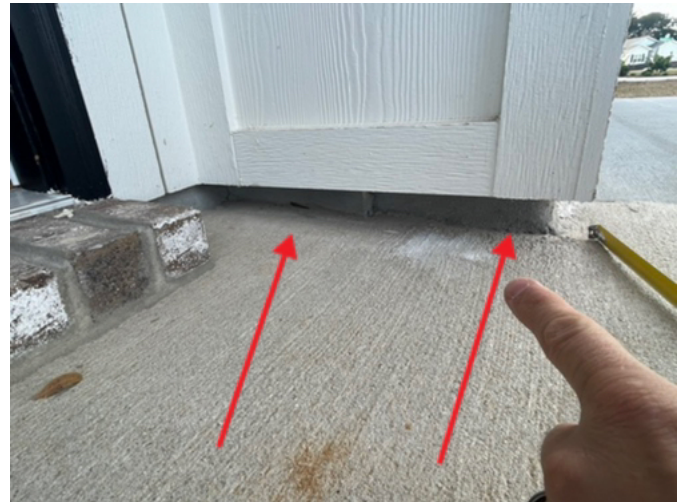
Bottom sill/wall plate is exposed at front entrance and offset at interior garage's left wall. It appears to not be properly sitting on foundation wall. Recommend inquiring with superintendent about width of bottom sill plate at this wall to determine if appropriate corrections were made to make it structurally sound.

Bottom sill plate not properly sitting on foundation wall.

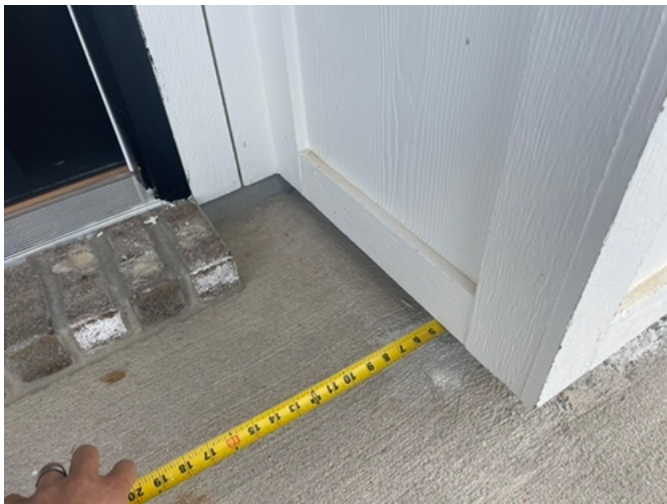
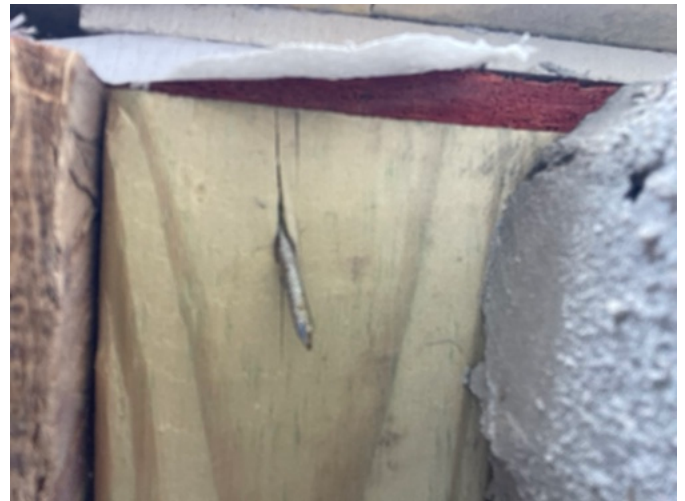
Exposed sill plate

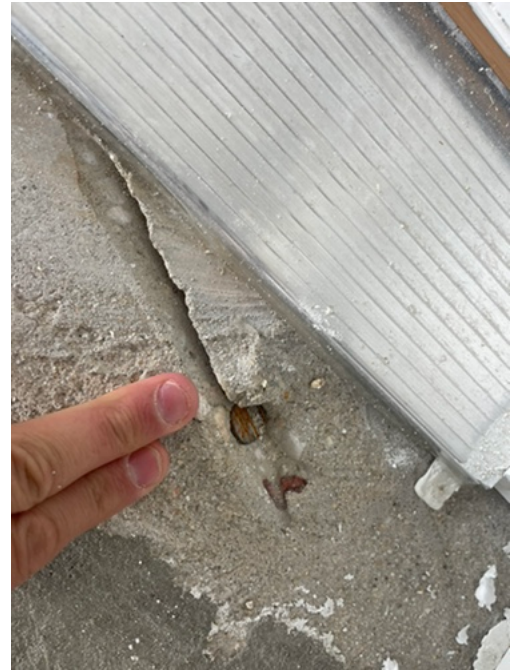
Garage's interior left wall showed alignment issue between foundation and interior left wall with cut strong tie bolts that should attach wall to sill plate. Recommend inquiring with superintendent about what modifications were made and if the sill plate is properly supported and attached by strong tie bolts to foundation wall.

Garage foundation wall has cut J bolts where wall was moved.

Cut J bolts for wall attachment

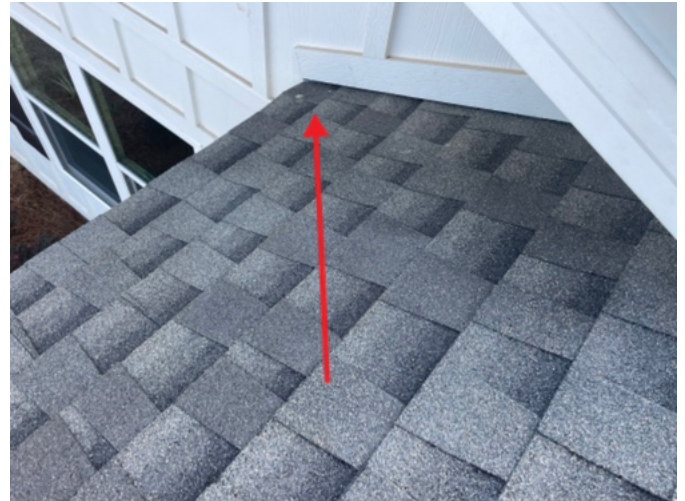
Location of missing diverter flashing.

Exterior roof covering is missing flashing over front entryway where roof butts into wall/siding. Recommend installing diverter flashing to prevent future moisture intrusion behind the siding/wall.

Missing diverter flashing

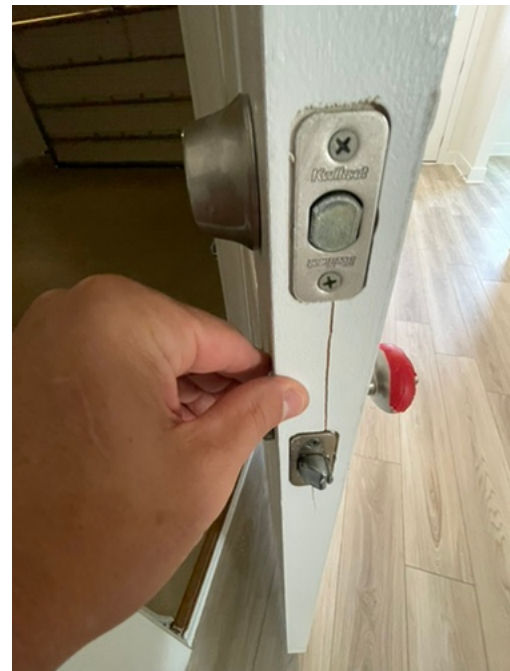
Interior garage service door has split door frame where hardware attaches to the door. Recommend replacing door.

Split door frame

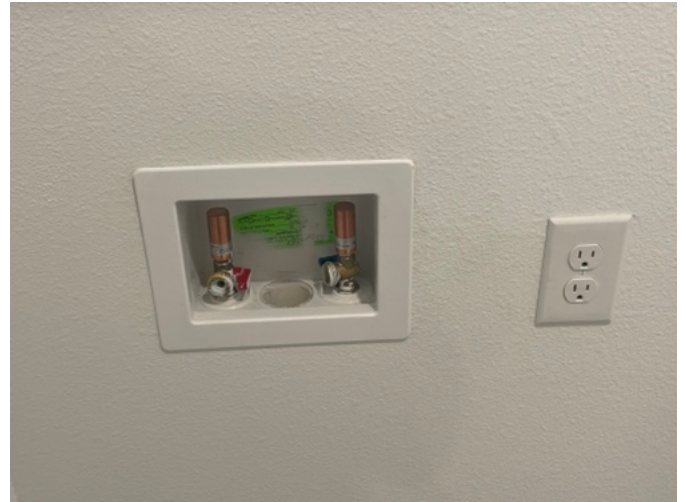
Laundry room's cold water shut off valve is twisted. Recommend adjusting to face forward for better usage/attachment.

Twisted cold water valve

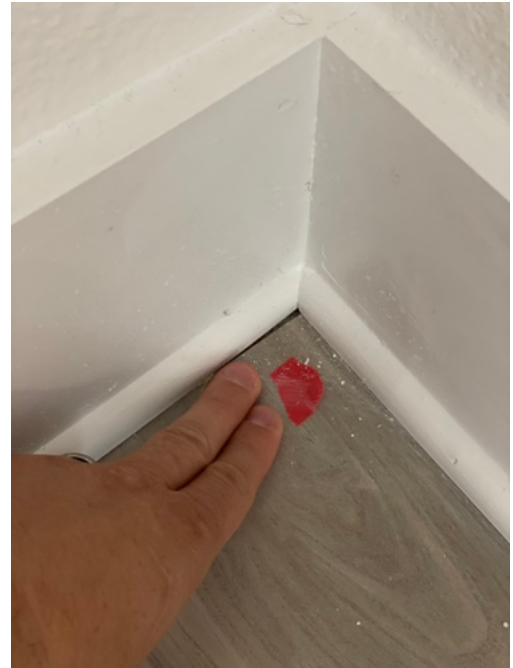
Living room has gap between flooring and baseboard to the right of the refrigerator wall. Recommend improvements.

Gap between flooring and baseboard trim

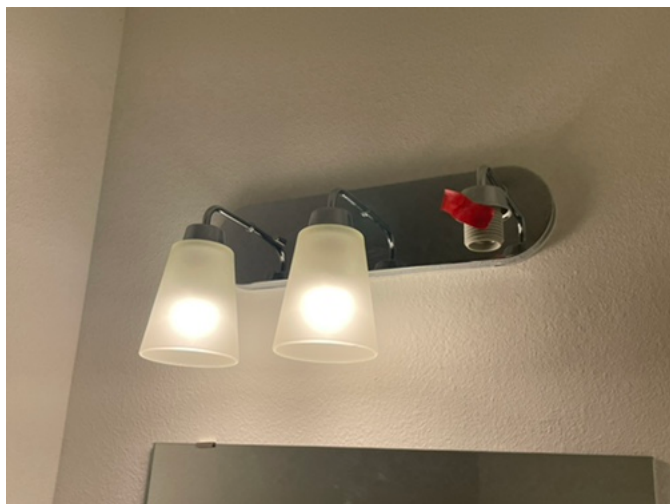
Guest bathroom has vanity mirror that is crooked & vanity light fixture that is missing lightbulb and light cover. Recommend installing with repairs.
