# Home Inspection Report

## Jekel Inspections

**Pensacola, Florida 32514**

**Inspection Date** 12/13/2023

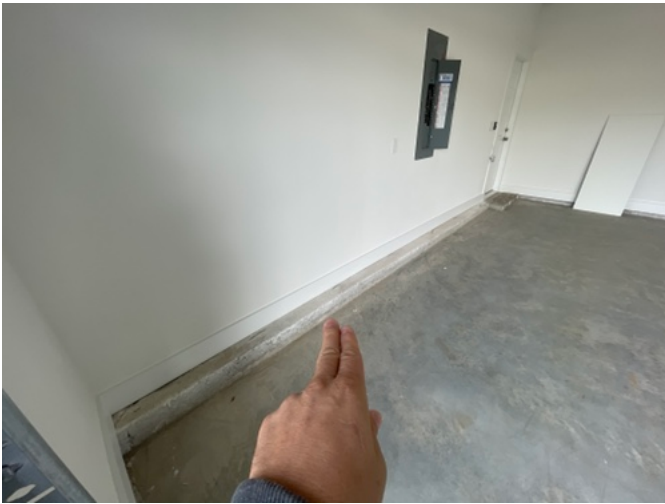
Garage's interior left wall showed alignment issue between foundation and interior left wall with cut strong tie bolts that should attach wall to sill plate. Recommend inquiring with superintendent about what modifications were made and if the sill plate is properly supported and attached by strong tie bolts to foundation wall.

Garage foundation wall has cut J bolts where wall was moved.

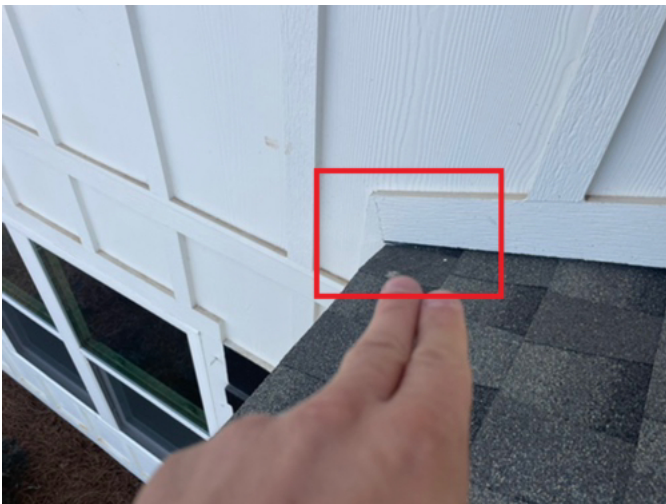
Exterior roof covering is missing flashing over front entryway where roof butts into wall/siding. Recommend installing diverter flashing to prevent future moisture intrusion behind the siding/wall.

Missing diverter flashing

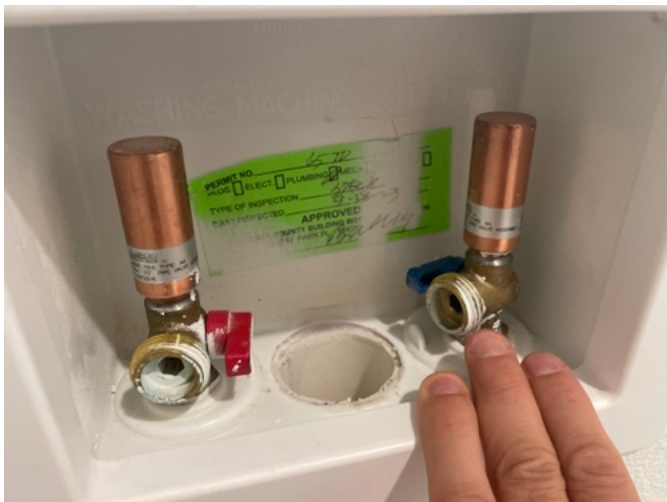
Laundry room's cold water shut off valve is twisted. Recommend adjusting to face forward for better usage/attachment.

Twisted cold water valve

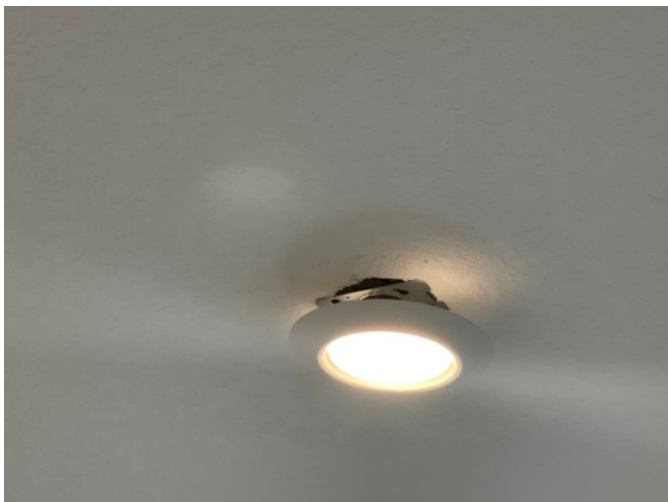
Loose light fixture over front entrance hallway. Recommend better securing to junction box/ceiling.

Loose LED light at front entrance hallway

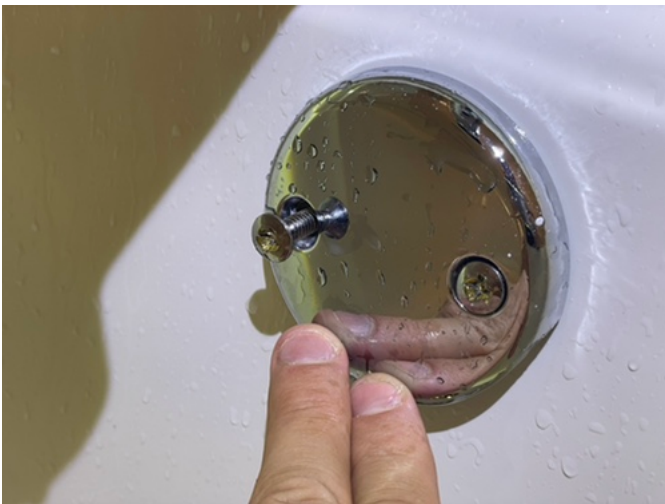
Hallway bathroom's bathtub had loose overflow faceplate at. Recommend adjustment/tightening of fasteners.

Loose overflow cover
