# Home Inspection Report

## Jekel Inspections

**Pensacola, Florida 32514**

**Inspection Date** 12/13/2023

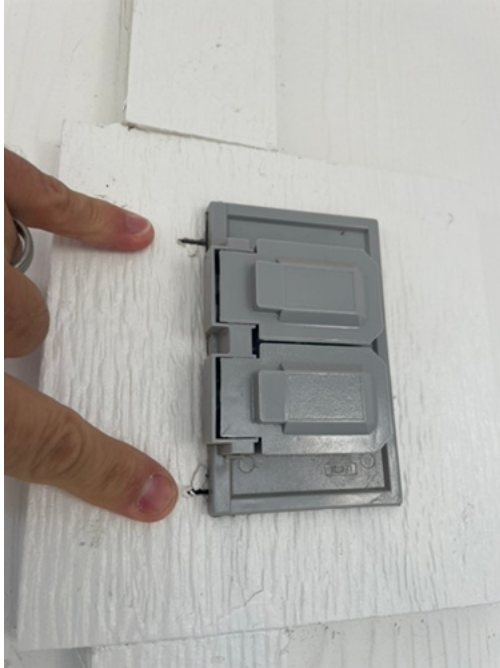
Exterior rear elevation porch had oversized cuts at trim around electrical outlet. Recommend improving finish.

Oversized trim cuts

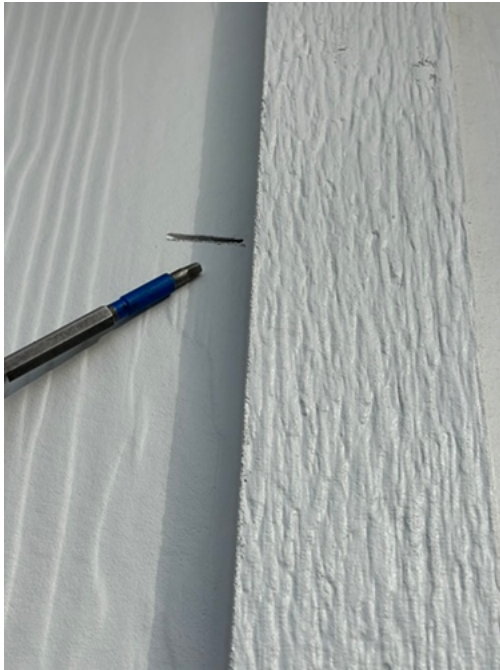
Exterior left elevation had cut damage to composite siding. Recommend repairing.

Damaged area

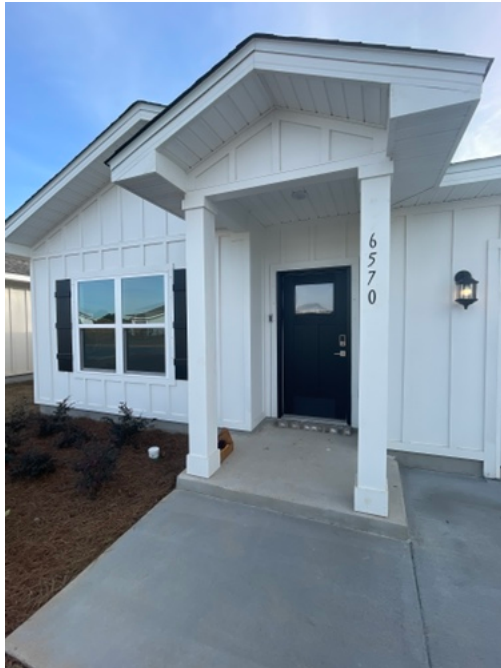
Bottom sill/wall plate is exposed at front entrance and offset at interior garage's left wall. It appears to not be properly sitting on foundation wall. Recommend inquiring with superintendent about width of bottom sill plate at this wall to determine if appropriate corrections were made to make it structurally sound.

Bottom sill plate not properly sitting on foundation wall.

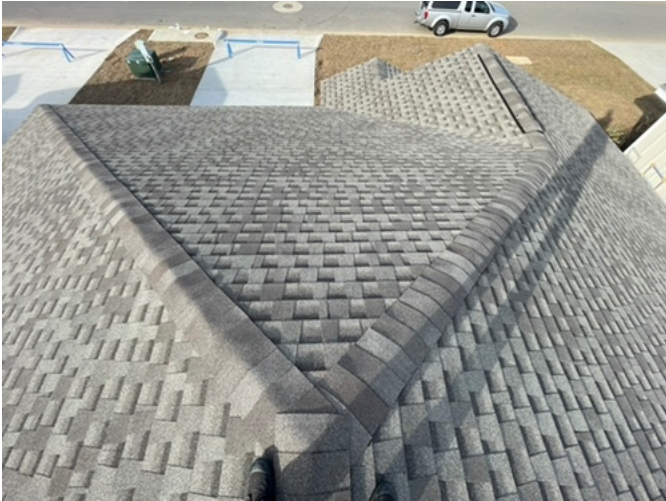
Exterior roof covering is missing flashing over front entryway where roof butts into wall/siding. Recommend installing diverter flashing to prevent future moisture intrusion behind the siding/wall.

Location of missing diverter flashing.

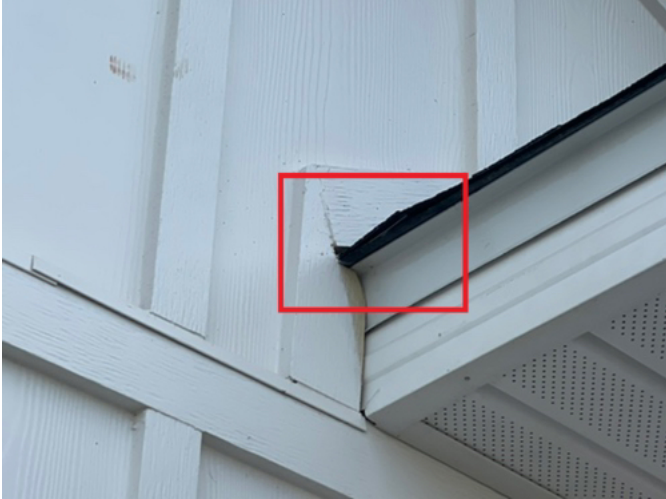
Exterior roof covering is missing diverter flashing where roof covering connects to wall which can lead to moisture intrusion behind the siding causing moisture related problems. Recommend installation of diverter flashing by roofer.

Missing diverter flashing

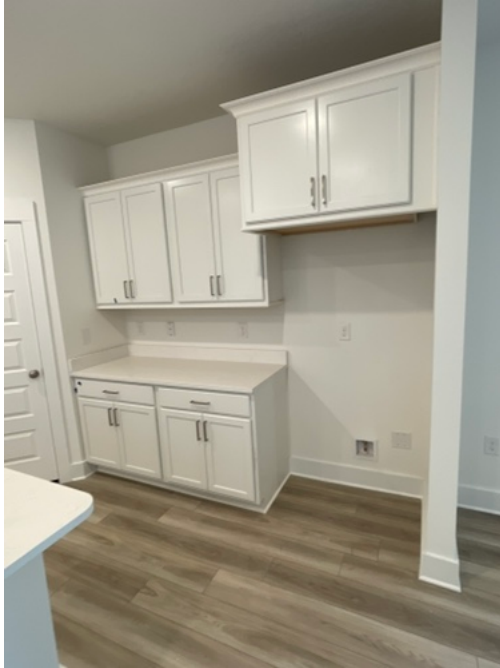
Kitchen cabinets appeared to be in functional condition at the time of inspection.

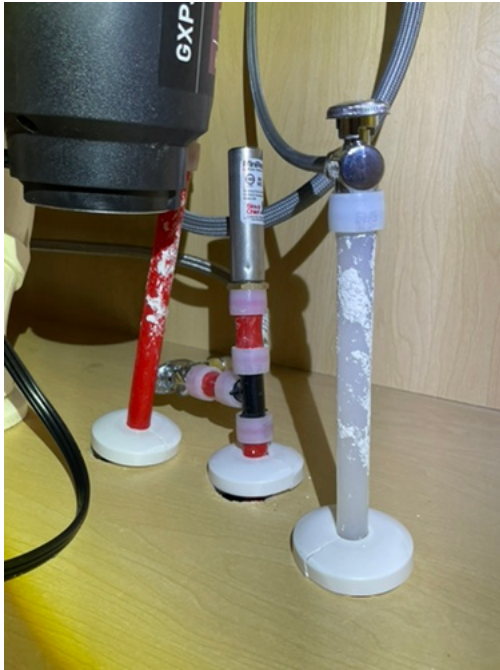
Kitchen sink and plumbing appeared to be in functional condition at the time of the inspection.

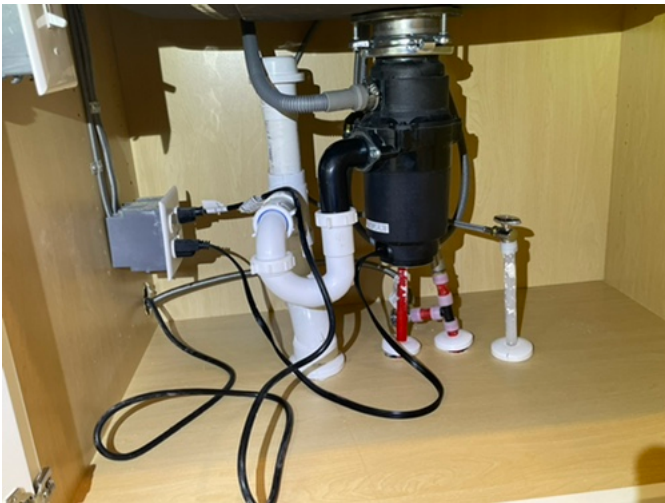
Kitchen garbage disposal was operable at the time of the inspection.

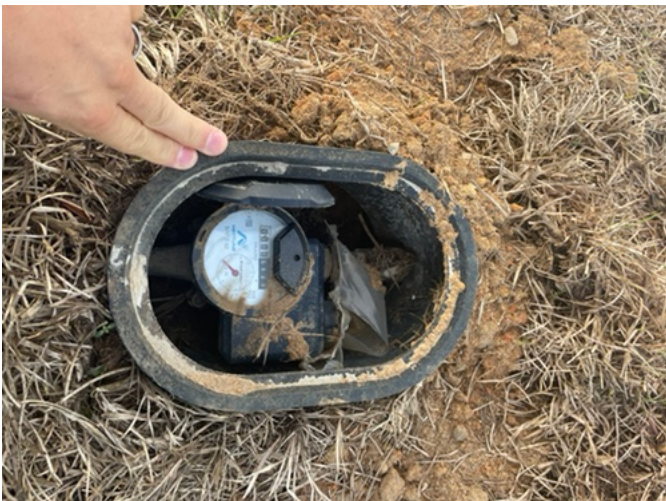
Exterior main water shut off box/water meter is missing cover lid. Recommend installation.

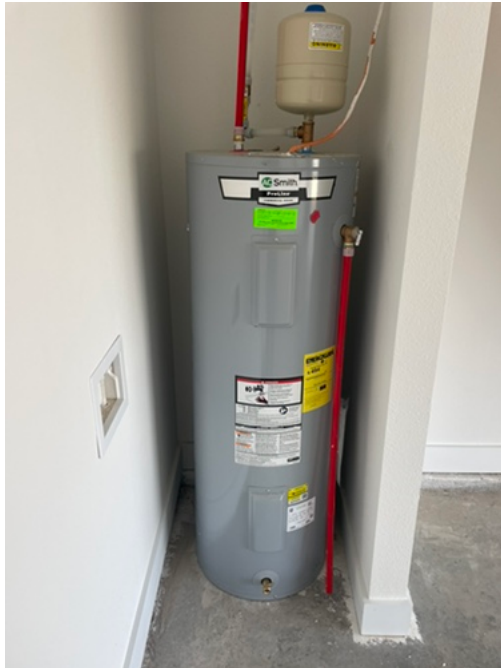
AO Smith 2023

The water heater was functional at the time of inspection.

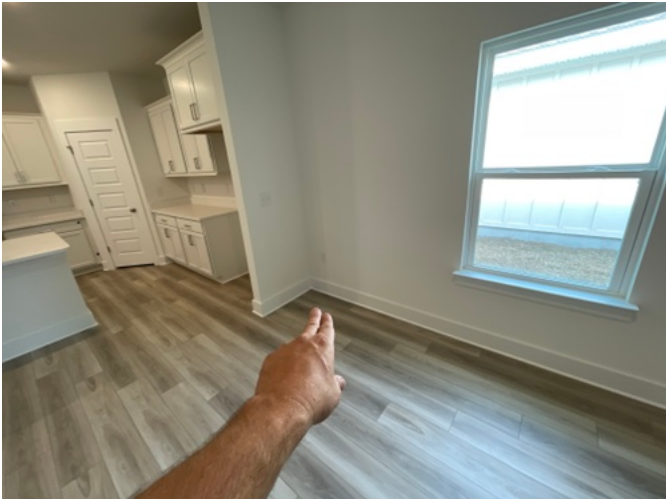
Living room has gap between flooring and baseboard to the right of the refrigerator wall. Recommend improvements.

Gap between flooring and baseboard trim

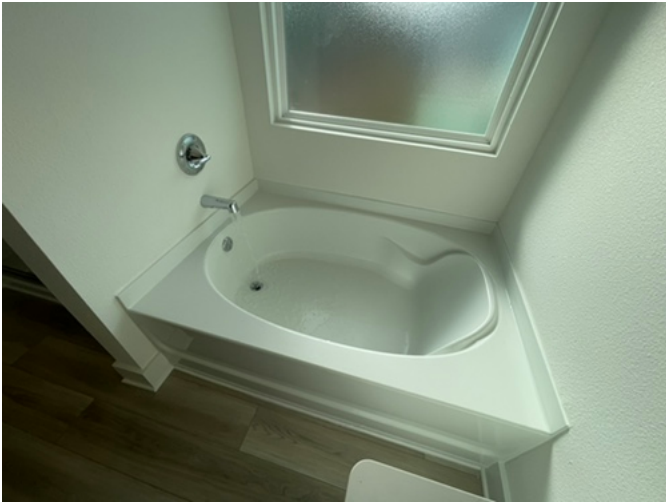
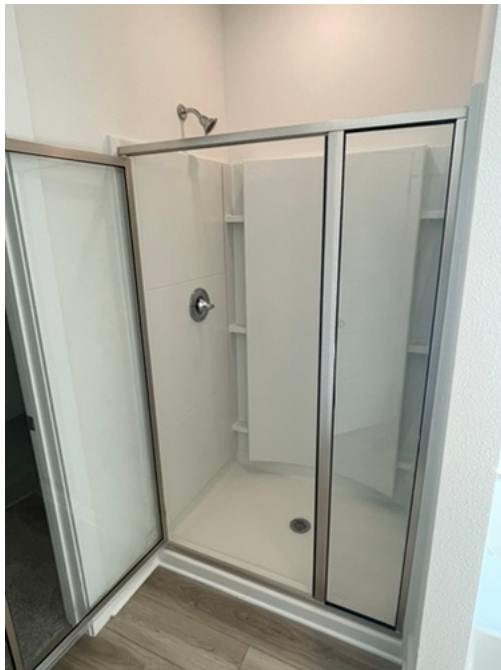
Hallway bathroom's bathtub had loose overflow faceplate at. Recommend adjustment/tightening of fasteners.

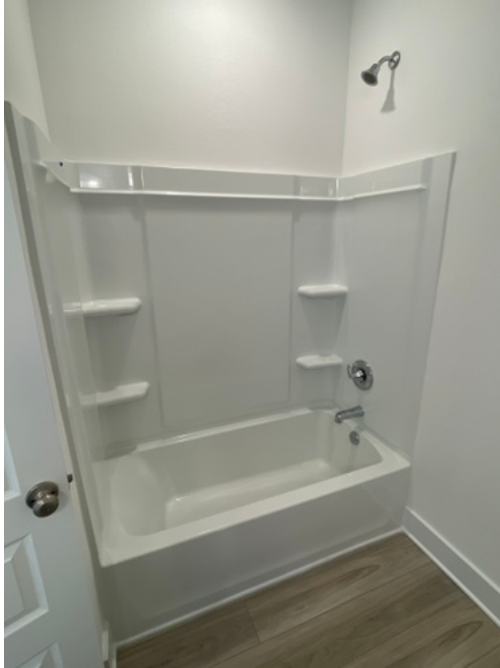
Loose overflow cover

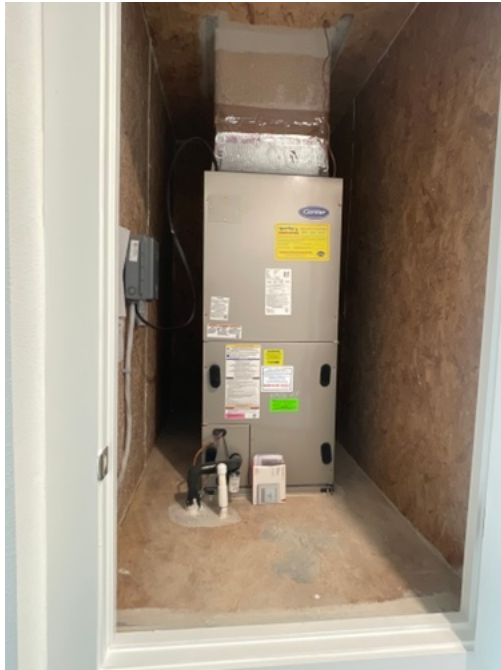
Carrier 2023

Air handler appeared functional at the time of inspection.

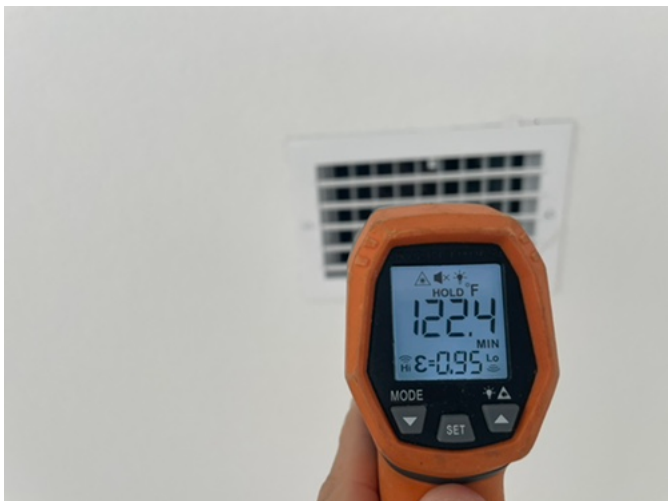
Heat Cycle only
